Addendum No.2

Fire Station 2 Tenant Improvements Project

Asbestos Survey Report

Asbestos Survey for Fire Station #2 300 Spencer Ave in Sausalito, California

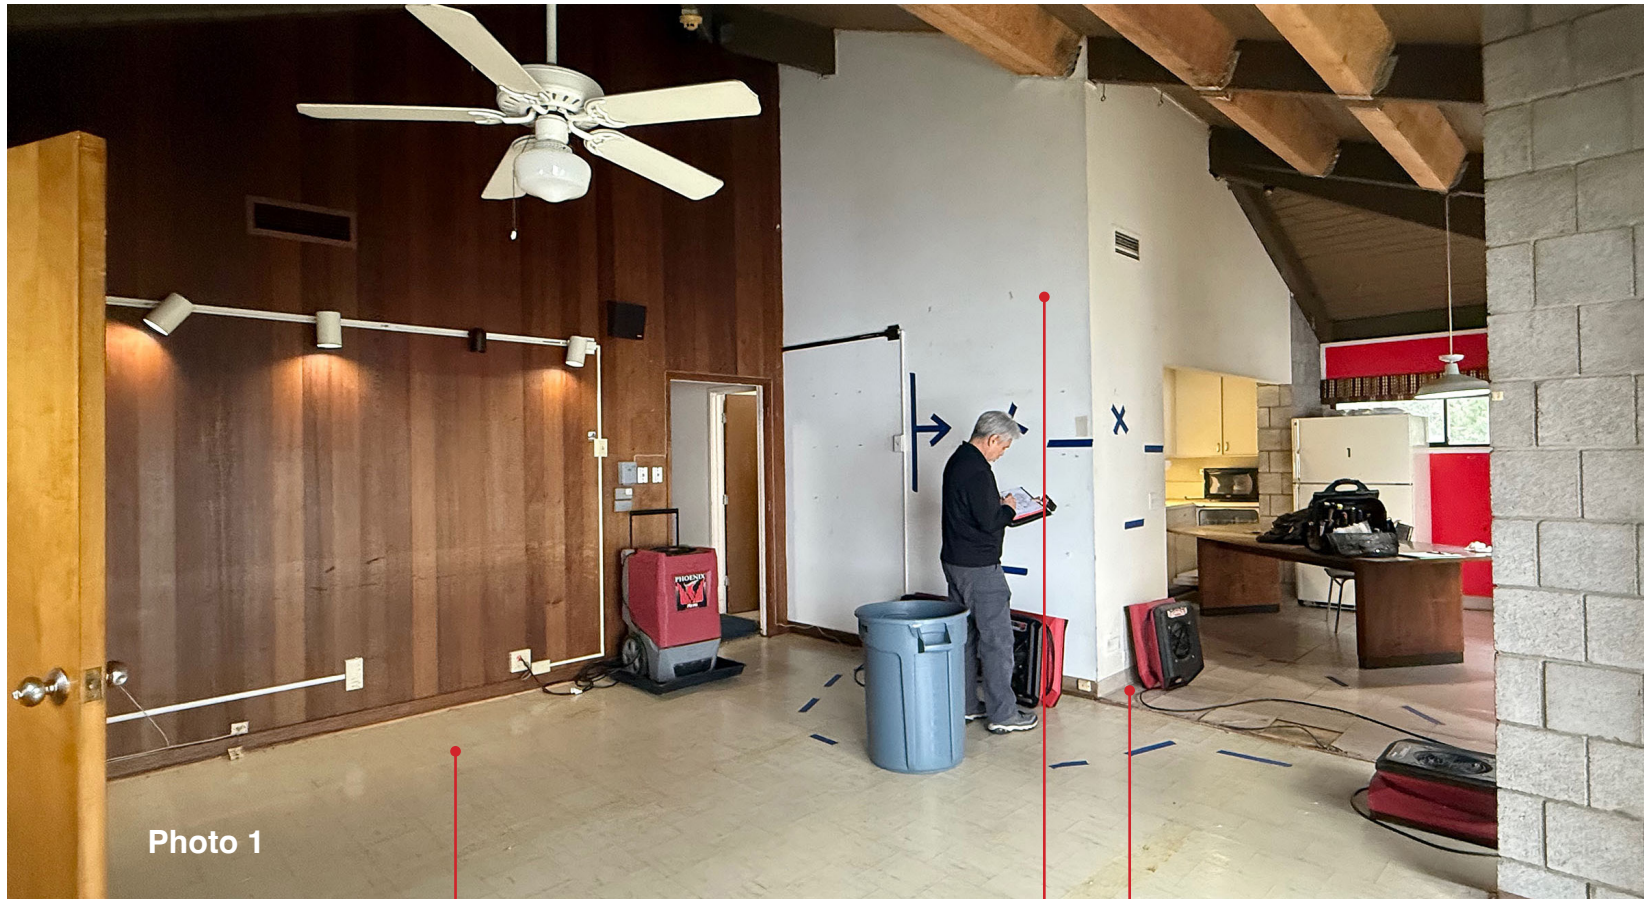
Photo 1

The flooring at the day room is 9 x 9 vinyl tile applied using a black cutback mastic. The 9 x 9 tiles and the mastic are both positive for asbestos. Any disturbance will require trained abatement contractors following Cal / OSHA CCR Title 8, section 1529 regulations.

The walls, in most locations use drywall board finished with joint tape compound. The compounds contain more than 1% asbestos and will require being treated as asbestos containing materials (ACM) above 1%.

The floor in the dining room and kitchen use 12 x 12 vinyl tile applied with a tan colored mastic. The 12 x 12 tile and mastic are both non detect for asbestos and will not require abatement in this location. The cove base is also non detect for asbestos. Please refer to the complete report for details.

1. The 9 x 9 floor tile and black mastics shall be abated using Class II abatement practices for asbestos, in the areas scheduled for renovation. Any removal shall be performed using Wet methods, negative pressure containment, following all applicable regulatory guidelines.

2. The drywall compound at the walls of the second floor scope area contain more than 1 % asbestos. The removal of the gypsum board / drywall will require the use of abatement contractors using wet methods, critical barriers, following all regulatory requirements. Notification to the AQMD and waste handling may be required for ACM. All drywall compound debris must be disposed of in leak tight containers with appropriate warning labels. Cal / OSHA regulations apply to materials with any detectable asbestos, such as this. The combination of joint compounds and gypsum board may be composite tested to yield less than 1% asbestos content.
